TITLE:
ROOF HATCH,
THERMALLY BROKEN,
REPLACEMENT COMPONENTS

SIZE	DWG. NO.	REV
B	RETRO-FIT KITS	-

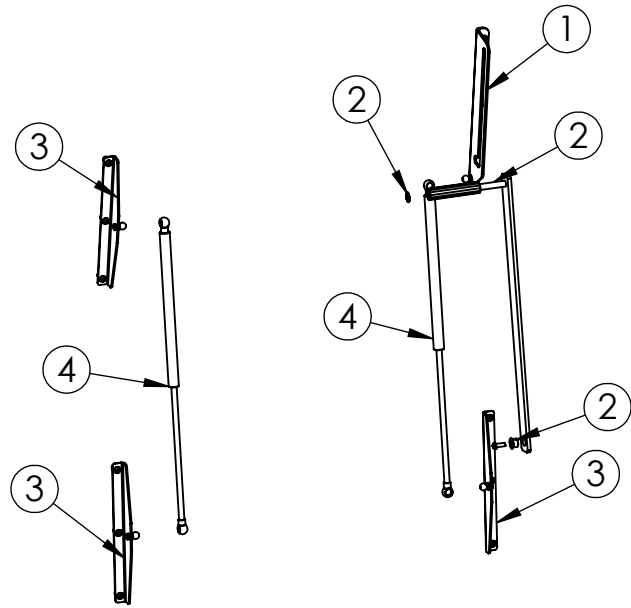
ROOF HATCH KITS	
DETAIL	DESCRIPTION
①	HOA/SPRING
②	COVER LATCH
③	LATCH CATCH
④	HINGE
⑤	GASKET

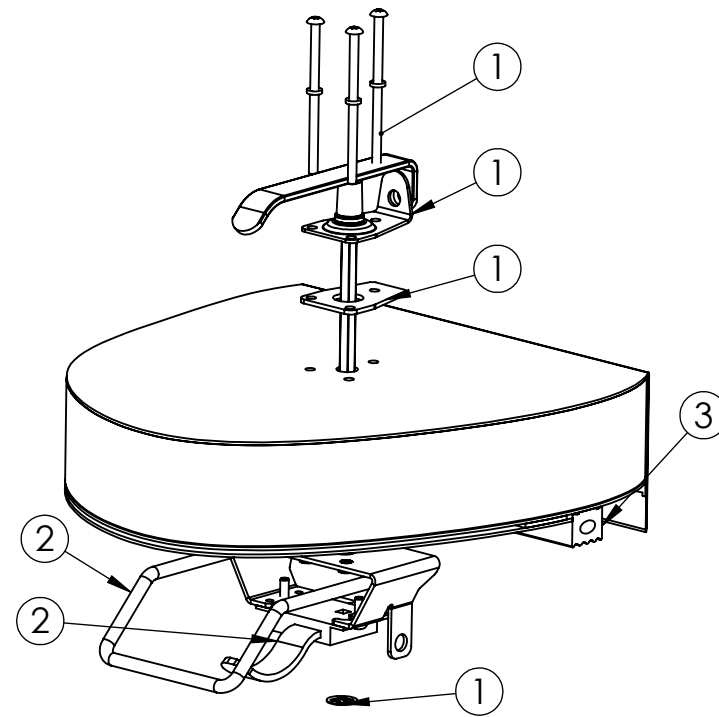
REPLACEMENT HOA/SPRING

ITEM	REPLACEMENT KIT #	OEM PART #	DESCRIPTION
①	RHT-KIT-HOACOVER	29940	PKG, HOA COVER BRACKET
②	RHT-KIT-HOACURB	30410	PKG, HOA AND HARDWARE
③	RHT-KIT-SPRINGBRKT	30623	PKG, SPRING BRACKET
④	RHP11-KIT-SPRING-150	30628	PKG, 150N SPRING
④	RHP11-KIT-SPRING-250	29880	PKG, 250N SPRING
④	RHP11-KIT-SPRING-500	29881	PKG, 500N SPRING
④	RHP11-KIT-SPRING-600	30269	PKG, 600N SPRING

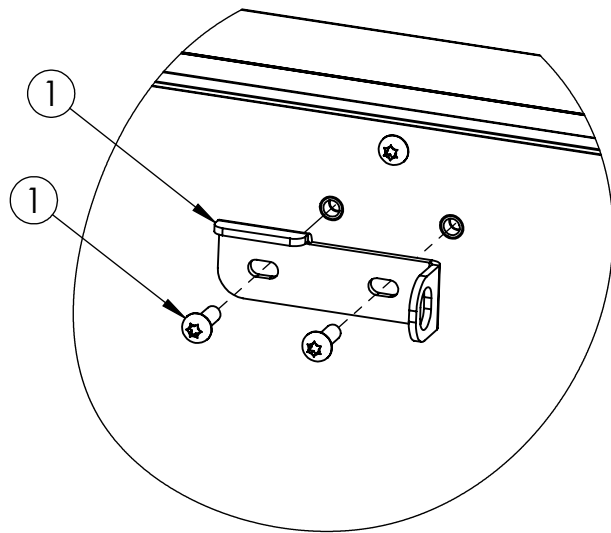
REPLACEMENT COVER LATCH/GASKET

ITEM	REPLACEMENT KIT #	OEM PART #	DESCRIPTION
①	RHT-KIT-EXTHDL	30303	PKG, EXTERIOR TURN HANDLE
②	RHT-KIT-INTHDL	29914	PKG, INTERIOR TURN HANDLE
③	RHT-KIT-GASKET	29527	PKG, GASKET

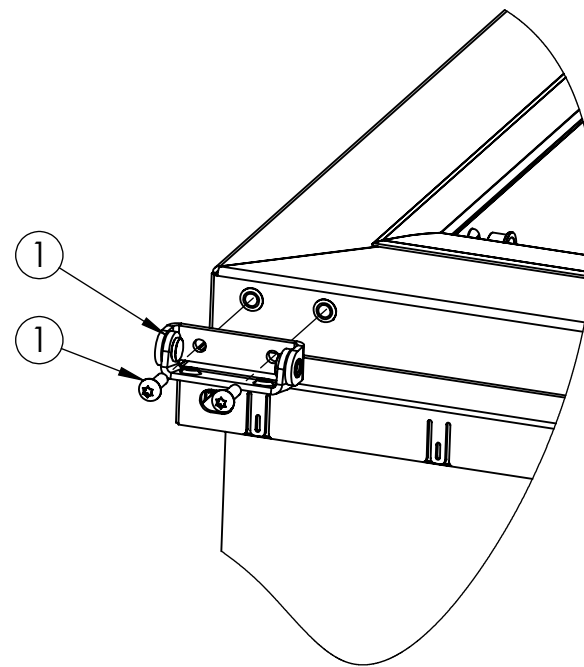
REPLACEMENT LATCH CATCH

ITEM	REPLACEMENT KIT #	OEM PART #	DESCRIPTION
①	RHT-KIT-CATCH	29936	PKG, LATCH CATCH

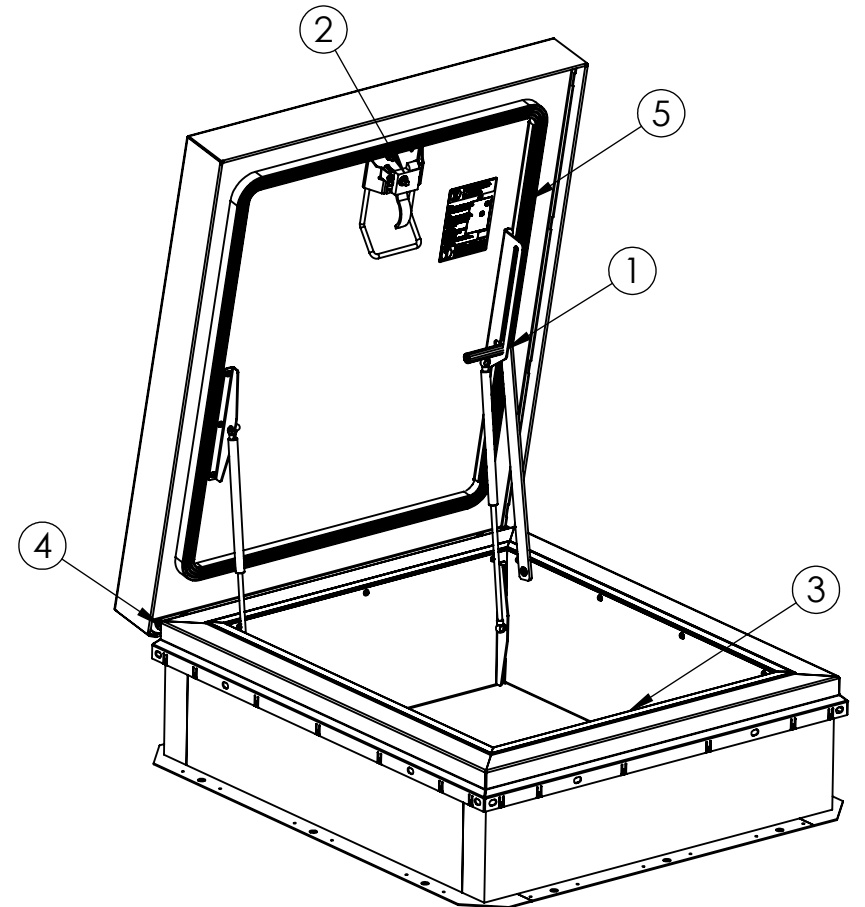
REPLACEMENT HINGE

ITEM	REPLACEMENT KIT #	OEM PART #	DESCRIPTION
①	RHT-KIT-HINGE	29941	PKG, HINGE

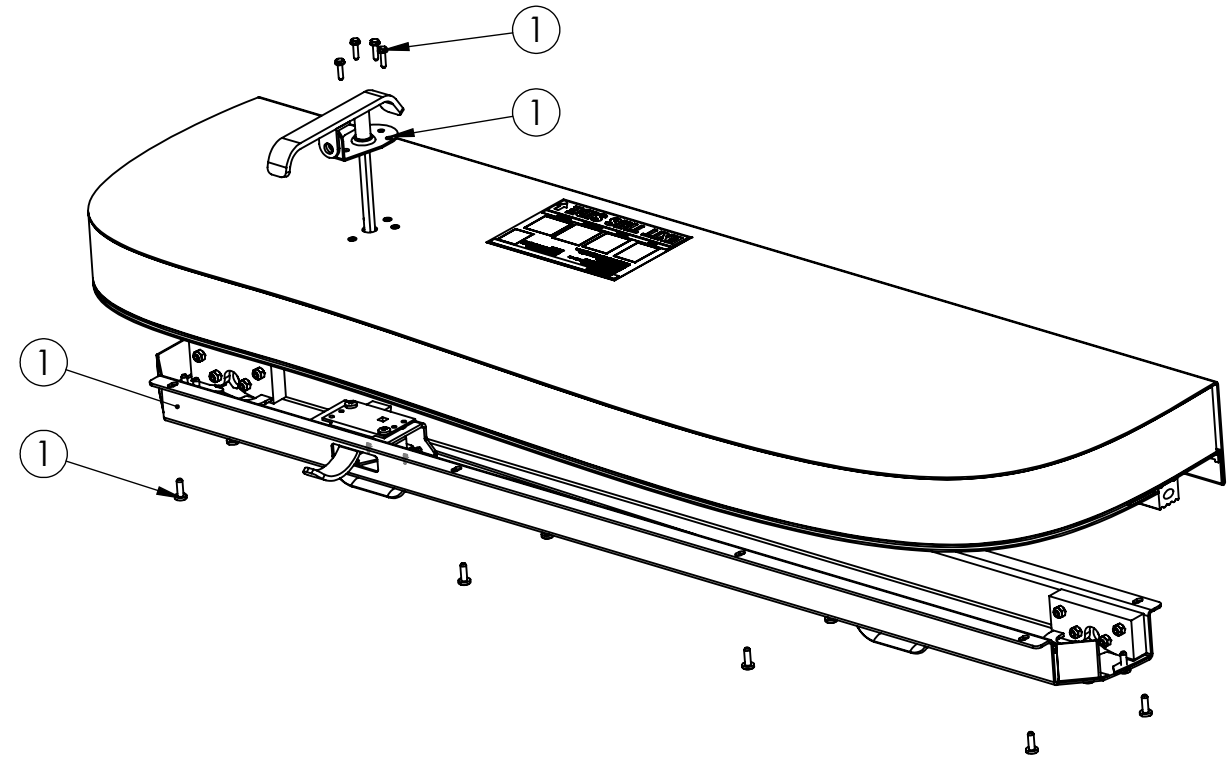
ROOF HATCH KITS	
DETAIL	DESCRIPTION
①	COVER LATCH
②	LATCH CATCH

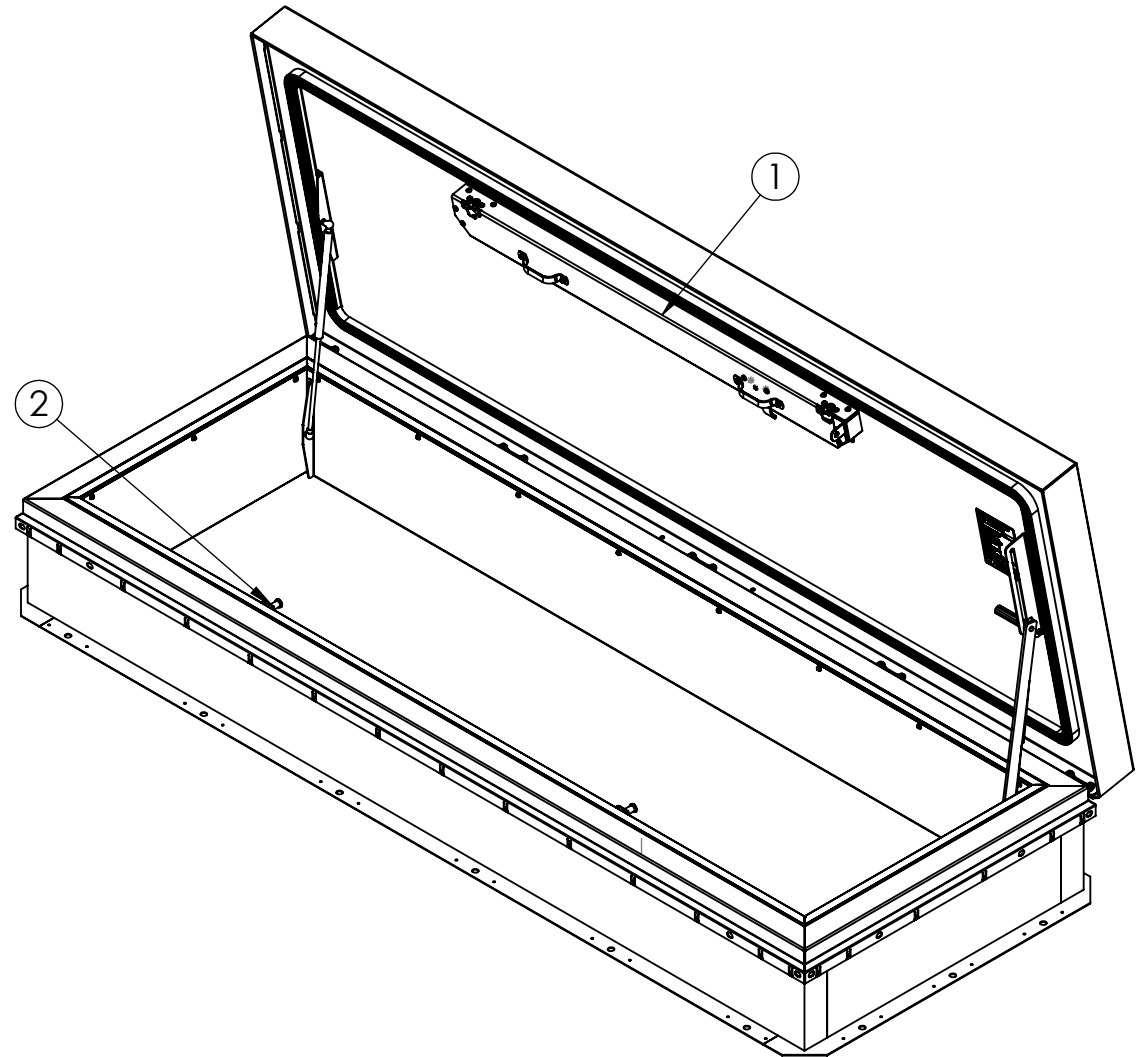
REPLACEMENT 2 POINT LATCH CATCH

ITEM	REPLACEMENT KIT #	OEM PART #	DESCRIPTION
①	RHT-KIT-2PTCATCH	28904	PKG, TWO POINT LATCH CATCHES
②	RHT-KIT-HASP	29675	PKG, PADLOCK HASP
